Contract #: 04-0120F4Cty: SF/ALA Rte: 80 PM: 13.2/13.9File #: 69.28**WELDING INSPECTION REPORT****Resident Engineer:**Pursell, Gary**Address:** 333 Burma Road**City:** Oakland, CA 94607**Report No:** WIR-000789**Date Inspected:** 01-Nov-2007**Project Name:** SAS Superstructure**OSM Arrival Time:** 1430**Prime Contractor:** American Bridge/Fluor Enterprises, a JV**OSM Departure Time:** 2300**Contractor:** Zhenhua Port Machinery Company, Ltd (ZPMC), Changxing Island **Location:** Shanghai, China**CWI Name:** Zhu Zhanghai & Xu Le Feng**CWI Present:** Yes No**Inspected CWI report:** Yes No N/A**Rod Oven in Use:** Yes No N/A**Electrode to specification:** Yes No N/A**Weld Procedures Followed:** Yes No N/A**Qualified Welders:** Yes No N/A**Verified Joint Fit-up:** Yes No N/A**Approved Drawings:** Yes No N/A**Approved WPS:** Yes No N/A**Delayed / Cancelled:** Yes No N/A**Bridge No:** 34-0006**Component:** OBG & Mock Up**Summary of Items Observed:**

Orthotropic Box Girder (OBG):

WELDING INSPECTION REPORT

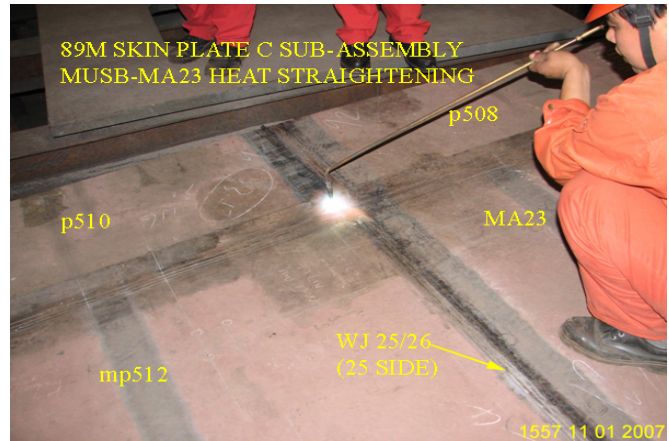
The QA Inspector randomly observed ZPMC welding personnel performing a heat straightening operation on 89M Skin Plate C Sub-Assembly MUSB-MA23. The QA Inspector randomly observed the heat being applied to an area directly adjacent to WJ 25/26 on the 25 side. The following photograph provides additional detail.
